OPEN Multi-criteria evaluation for the sustainable use of loess gullies in rural–urban borderline

The paper explores the issue of sustainable use of urban gullies under the pressure of suburbanization. The objective of this study was to provide guidelines for land restoration in relation to the Polish case study by analyzing (1) land cover changes, (2) their impact on the geomorphic evolution of gullies and (3) valuable plant associations. To this end, GIS technologies, identification of soil and sediments and valorization of plant associations were adopted to capture the total set of impacts. The findings revealed that land cover change indicators combined with geomorphological and plant aspects are useful for assessing the state of gully development and, on this basis, for providing revitalization recommendations. Long-lasting anthropogenic modifications were the main driving factors of gully development and exhibited significant interrelationships among all the indicators. This study revealed the need for strengthening the recreational use of gullies through multifunctional use by different citizen groups and for simultaneous protection of gullies in terms of geological and eco

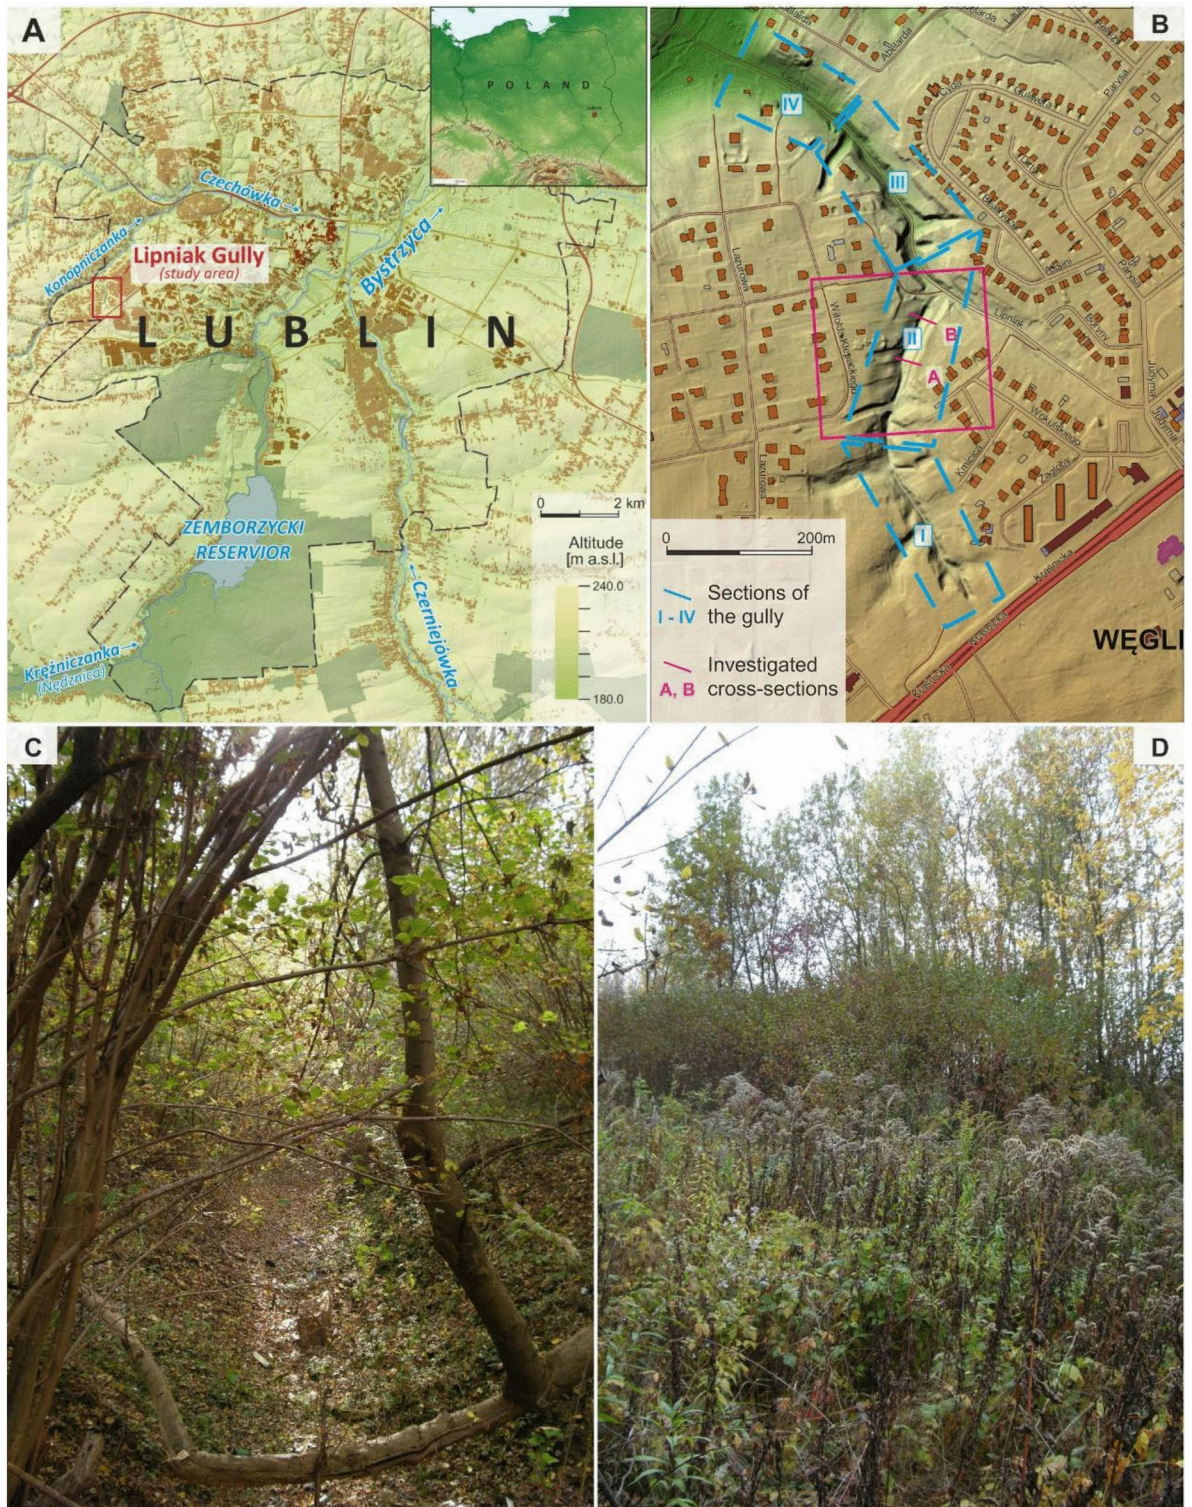
Fig. 1. (A) Relief of the Lublin area according to the digital elevation model (compiled by J. Kuna); (B) Lipniak gully area together with the investigated sections and cross-sections (compiled by J. Kuna); (C) the entrance to the gully from Lipniak Street (photo by B. Żuraw); (D) sequence of synanthropic plant (photo by B. Żuraw) (Compiled by J. Kuna & co-authors, using QGIS 3.16.7, CorelDRAW 2019 & Adobe Photoshop CS6 software).

One of the longest gullies in Lublin is called Lipniak and is located in the Węgliń district and flows into the Konopniczanka River valley (Fig. 1A, B). Four segments can be distinguished along the 800 m course, 3 of which are currently developed. The first one (I) of the SSE–NNW orientation is totally occupied by allotment gardens.

The second one (II) is of the SSW-NNE orientation and is still not developed (Fig. 1C, D). The third one (III), which is on the SSW-NNE orientation, has several lateral landforms, paved entrances to the property and an asphalt road (Lipniak Street), characterized by slopes occupied by clusters of linden trees (Fig. 2E). Similarly, the fourth outlet section (IV) has a SE-NW orientation and slopes developed with landscaped greenery (Fig. 2F).

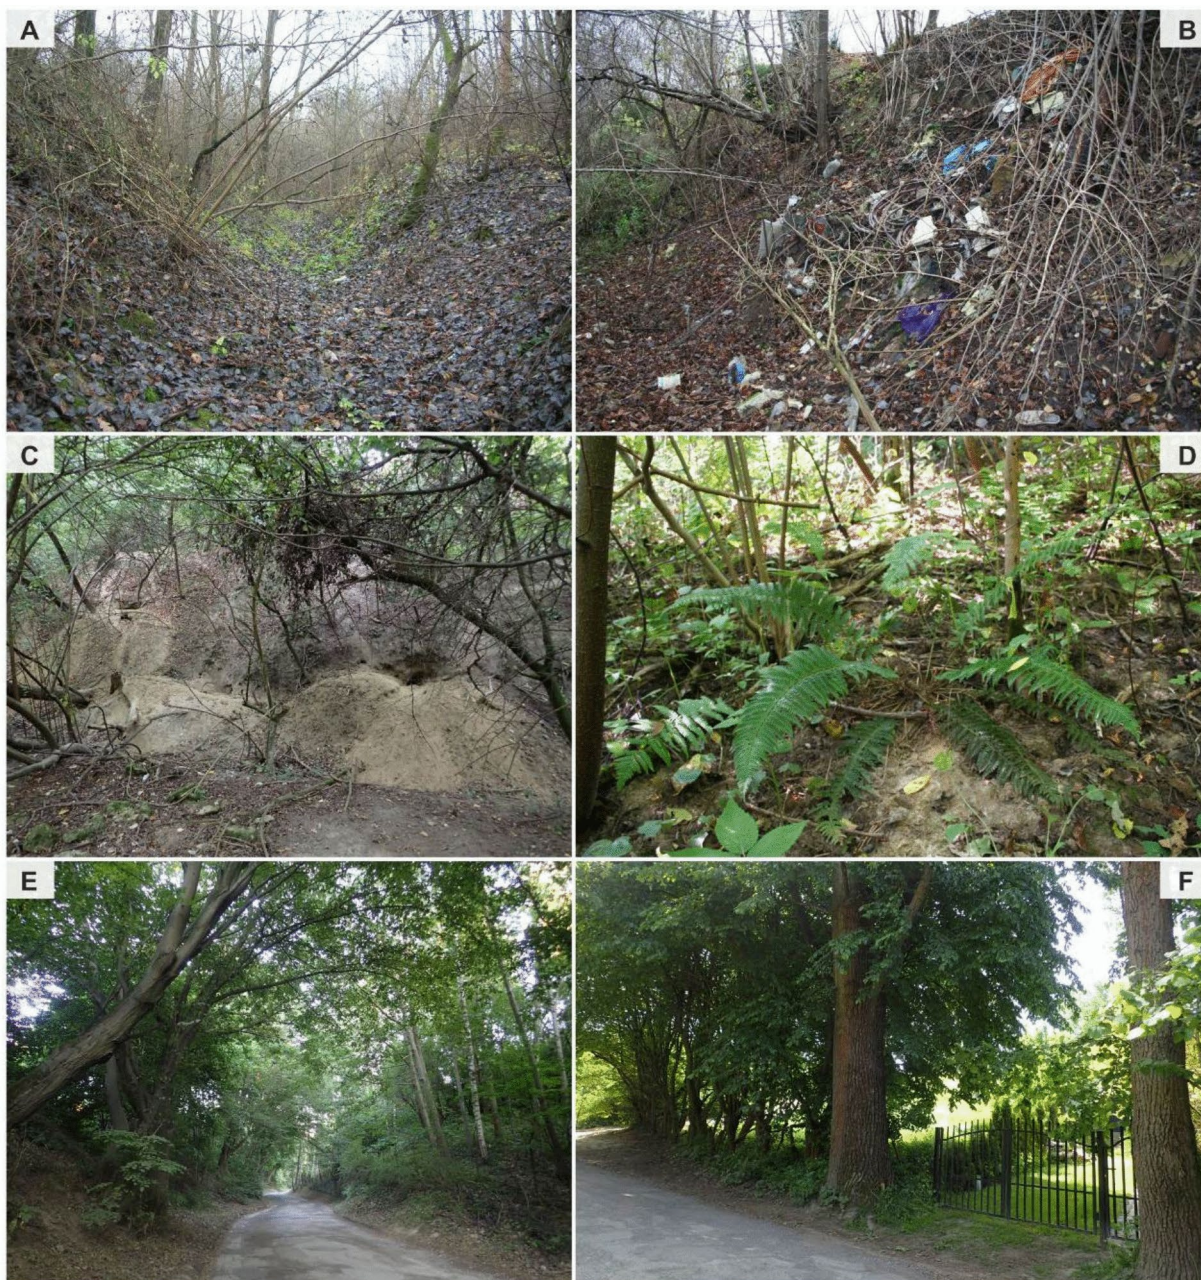
Fig. 2. (A) Mid part of the gully (photo by B. Żuraw); (B) a littered part of the gully (photo by B. Żuraw); (C) inhabited red fox burrow (photo by B. Żuraw); (D) hard shield-fern (photo by B. Żuraw); (E) asphalt road and slopes with old trees (photo by B. Żuraw); (F) landscaped greenery (photo by B. Żuraw) (Compiled by J. Kuna & co-authors).

In this study we assess the undeveloped section (II), which included neglected and littered segments of gully and is indicated in local plans for development as a pedestrian and bicycle path (Fig. 2A, B). Its geographical coordinates are $51^{\circ} 14' 11''$ N and $22^{\circ} 29' 03''$ E. This segment is barred from the side of Lipniak Street with a debris-soil embankment. To the right, it borders on allotments gardens. The floor and slopes of the gully are overgrown by dense tree and shrub vegetation to the left, fallow fields slope down to the gully, still with visible balks, usually overgrown by dozen-year-old trees or herbaceous plants. Open spaces are occupied by synanthropic plant communities (Fig. 1D) and ferns are found under the treetops (Fig. 2D). Some fragments of the gully are littered (Fig. 2B). Several fox burrows are located on the right slopes with ground heaps below their outlets (Fig. 2C).

- (1) The aspen thickets *Agrostio-Populetum tremulae* are associated with various succession stages, mainly the terminal phase. It is a low-elevation forest particularly composed of common aspen *Populus tremula* and a low number of goat willow *Salix caprea* in the tree layer. In the shrub layer, goat willow, common dogwood *Cornus sanguinea*, and black elder *Sambucus nigra* were dominant. On the transition B of the plateau into a slope, a shrub phase developed. Under aspen thickets on the left slope of the gully with an inclination of approximately a dozen degrees and ESE exposure, a site of occurrence of the protected plant hard shield-fern *Polystichum aculeatum* (Figs. 2E, 8A, B)

The existence of hard shield-fern on the left slope of the gully showed the unique ecological value of the site as this species is under legal protection in Poland. In addition, for ecological reasons, however, elements are numerous high vegetation forms (those that persist for more than 120 years) in proximity to gullies. In section II of the gully, there are 15 specimens of dendroflora that, based on the Regulation of the Polish Minister of the Environment⁴⁶, can be considered eligible for protection in the form of natural monuments: 11 individual common hazel *Corylus avellana* and one each of Norway maple *Acer platanoides*, common hawthorn *Crataegus monogyna*, common hornbeam *Carpinus betulus* and crab apple *Malus sylvestris*. The slopes of the ravine in the III section, where the paved road runs, are also covered with stately trees, whose crowns meet and form a shaded green tunnel. It is a place frequented by walkers and cyclists (Fig. 2E). The charms of the place were recognized with a jury's award, in the "Space" category, in the first edition of the "Cultural Treasures of Space" poll in 2019 (<http://teatrnn.pl>). In the bottom of the ravine in section IV of the ravine, 2 specimens of black poplar *Populus nigra* of monumental size were inventoried (Fig. 2F).

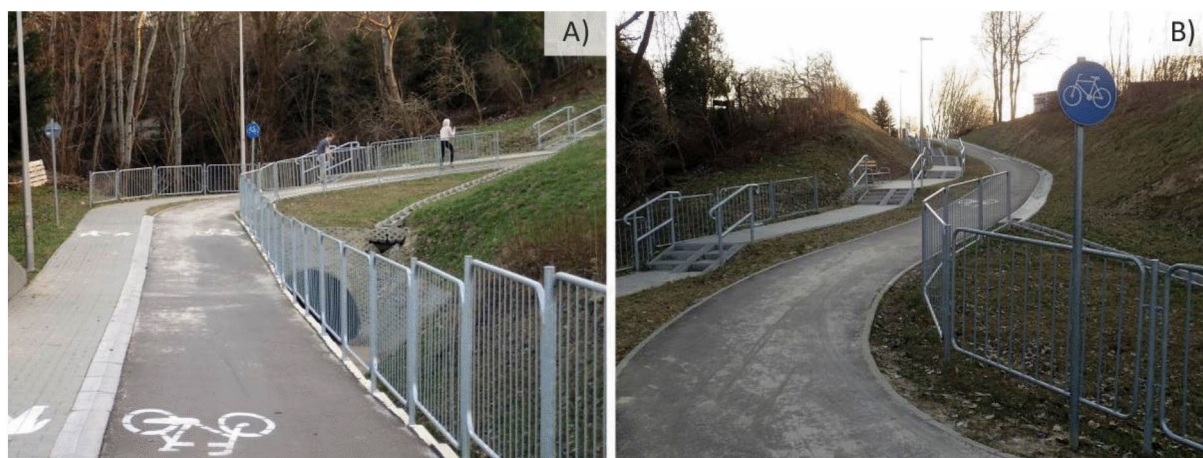
Fig. 3. Pedestrian and bicycle paths across the Lipniak Gully implemented in 2015: (A) on the terrace and above the culvert (photo by J. Rodzik); (B) in the excavation on the left slope (photo by J. Rodzik) (Compiled by J. Kuna & co-authors).

consulted with scientists studying human–environment interactions concerning Lublin’s gullies. As a result, the project, completed in 2017, significantly impacted the ecological value of the area by altering the land’s natural relief and introducing materials such as concrete, steel, and asphalt. The project covered only the construction of a concrete pedestrian and bicycle path through the second (II) section of the ravine. The route begins at Lipniak Street with a terrace cut above the right slope of the ravine, crosses it via a high drainage culvert, and then ascends the bottom of the excavation to the left slope, ending at Klepackiego Street. The 400-m-long route comprises a 2-m-wide asphalt and concrete bicycle path and a 1.5-m-wide pedestrian path made of concrete cobblestones. The route is equipped with safety barriers, benches, and lanterns (Fig. 3A, B).

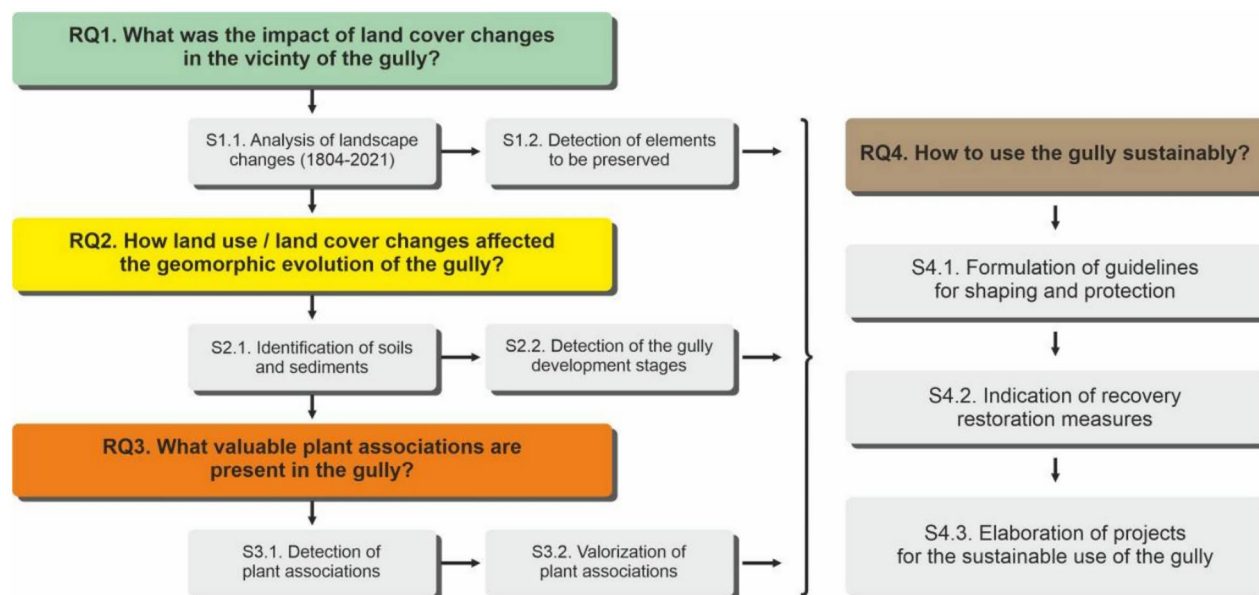
Fig. 4. Methodological framework (Compiled by J. Kuna & co-authors, using CorelDRAW 2019 & Adobe Photoshop CS6 software).

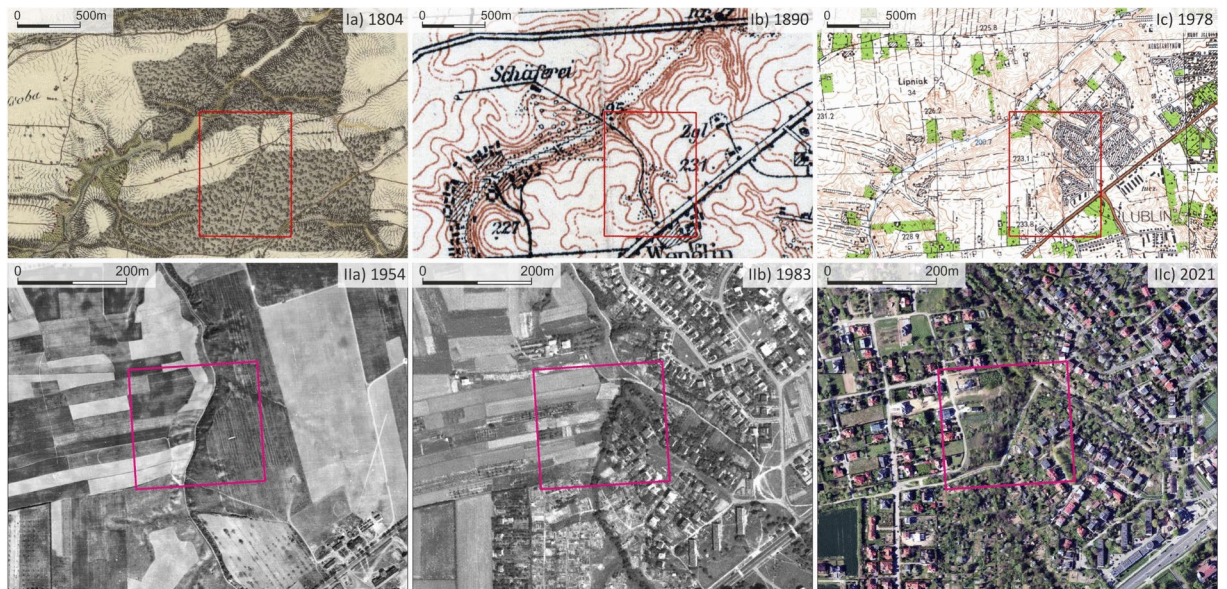
Fig. 5. Land use structure of the Lipniak gully area; **(Ia–c)** Lipniak gully and surroundings on archival topographical maps; all maps rescaled to approx. 1:40,000; **(IIa–c)** Segment 2 on archival aerial images and contemporary ortophoto; all images rescaled to approx. 1:9000; (Compiled by J. Kuna & co-authors, using QGIS 3.16.7, CorelDRAW 2019 & Adobe Photoshop CS6 software) List of primary cartographic sources is provided in Appendix B and C.

road was established on the floor of the dry valley running from the manor farm to a sheepfold on the other side of the Konopniczanka River valley (Fig. 5_Ib, (Table 1, stage Ib). The arrangement of arable fields has been known since the end of the first half of the twentieth century (Fig. 5_IIa; Table 1, stage IIa). On the right side of the gully, there were multistripe fields parallel to the road. On the left, in section II, there are narrow plots of land along the slope perpendicular to the road. After the 2nd World War and the political transformation, the manor farm was nationalized and partially parceled, and the PGR Węglin was established and incorporated into the territory of the city in 1959⁴⁵ (Fig. 5_Ic). In the early 1980s, allotment gardens were established occupying the first segment of the gully (Fig. 5_IIb). The along-slope fields on the left side of the second segment of the gully were cultivated by the farmers of Konopnica village at least until the next political transformation in 1989, when they were incorporated into the territory of the city (Table 1, stage IIb). Currently, allotment gardens are still present on the right bank of the gully, but buildings (estate of single-family houses) are being constructed on the left bank of the gully at the place of the former agricultural areas. In addition, trees and shrubs enter the bottom of the gully (Fig. 5_IIC, Table 1, stage IIIa-b).

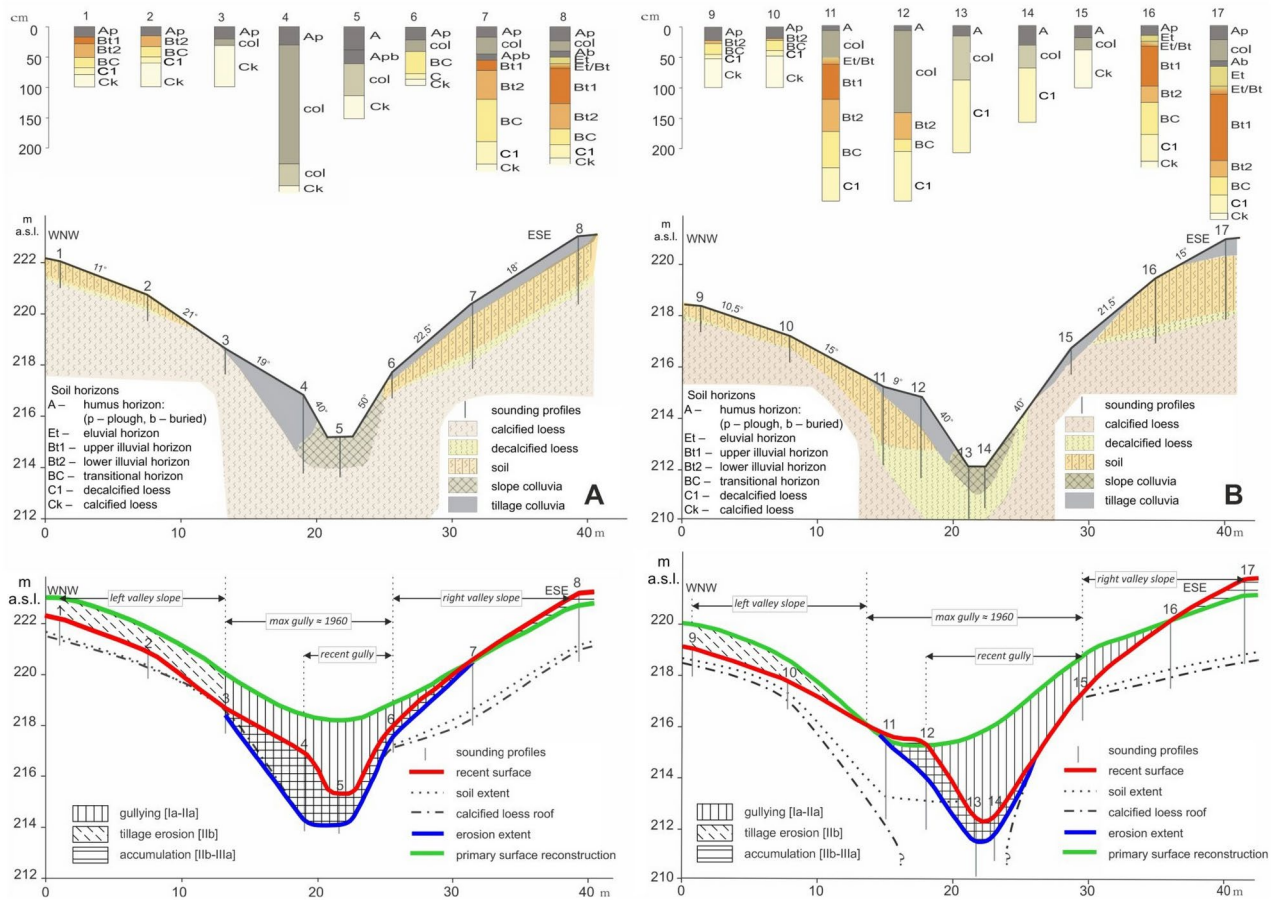
Fig. 7. (A) Cross-section A across the Lipniak valley form located 130 m from the road; (B) Cross-section B across the Lipniak valley form located 50 m from the road; Top—soil profiles and soil catena; bottom—reconstruction of the primary valley form (Compiled by J. Kuna & co-authors, using CorelDRAW 2019 & Adobe Photoshop CS6 software).

The cross-sections of segment II of the valley-gully form of the Lipniak show general similarity to letter V with evidently convex slopes. In the upper part, they usually have an inclination of 10°–15°, in the middle part, they have an inclination of 15°–20°, and in the lower part, they have an inclination of 40°–50° (Appendix A). The valley is asymmetric; the left slope has a height of 6–7 m and a lower inclination, and the right slope has a height of 8–9 m and a greater inclination (Fig. 7A,B). Five types of soils were identified in the present study (Fig. 8A). Individual types of soil occupy small patches of various lengths—sometimes only a few meters. Typical original luvisols with a complex profile, A–Et–Et/Bt–Bt1–Bt2–BC–C–Ck, and a considerable depth of 1.5–2 m are particularly preserved in the upper part of the right slope. They were even aggradated by slope deposits from agricultural fields. On the left slope, in its upper part, the remnants of the original soil profile are mostly preserved. In the lower part of the left slope, an almost complete soil profile has been preserved in cross-section A, while in cross-section B, the soil has been eroded down to carbonate loess. Noteworthy in both cross sections is the significant thickness of massive arable colluvium deposited during mechanical plowing. In the gully floor, the soil profile was removed; loess is covered by slope colluvium with a thickness of approximately 1 m in the form of usually disorganized packages from slumps and locally laminated fluvial sediments.

The analysis of cross-sections and soil catenas and sediment in reference to land use/cover changes showed that the study area was subjected to complex geomorphological conditions (Table 1). The original natural landform was a dry trough-like valley (the valley shape was not either U nor V-shaped) with a depth of 5–6 m, where deep luvisol developed on the slopes under a typical broadleaf forest. The valley in this part was characterized by climatic asymmetry, with a steep slope with sunny exposure (ESE) and a gentle slope with shaded exposure (WNW). The difference between the inclination and exposure of the slopes, and thus their humidity, is reflected in the original thickness of the soil profile, which is much greater on the right slope. Such
